Evaluation Of Composite Materials For Use On Launch Complexes

DOCUMENT NO. MTB-402-89
DATE: NOVEMBER 30, 1989

TEST REPORT

Evaluation of Composite Materials
for Use on Launch Complexes

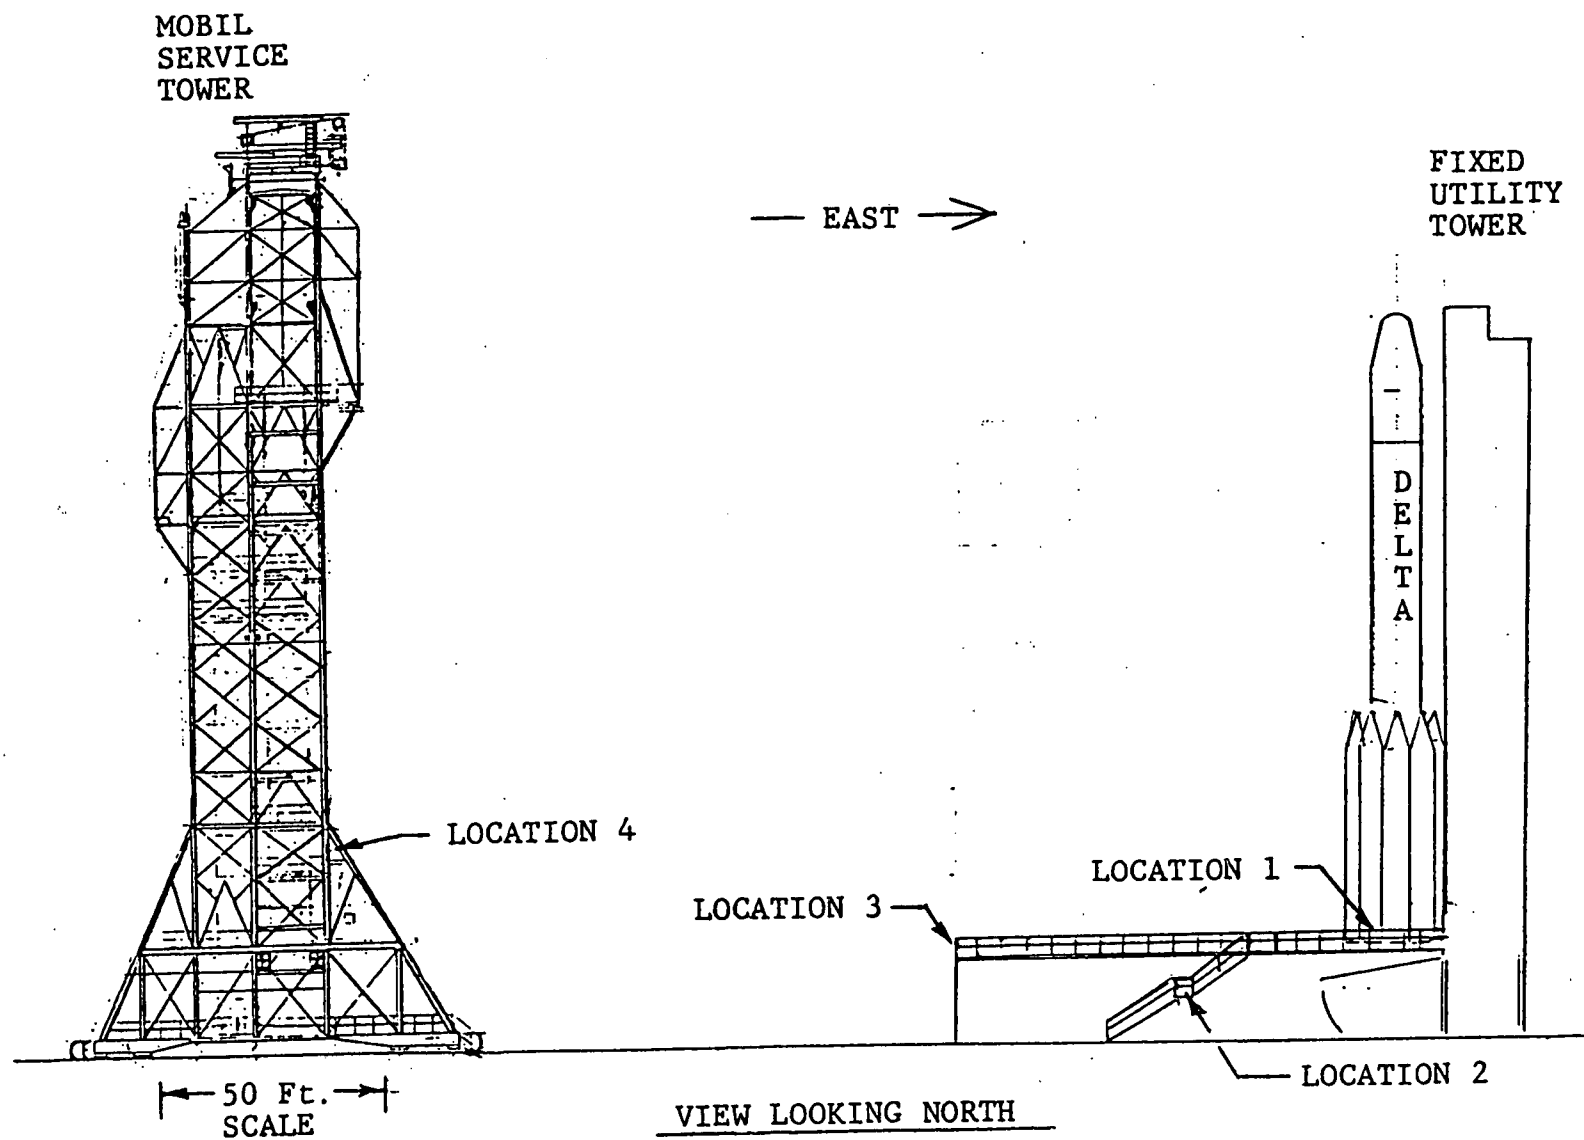
FIGURE 1

THE TEST LOCATIONS ON LAUNCH COMPLEX 17A ARE IDENTIFIED
IN THE DRAWING.

- 7.1 Samples of the composite channel materials were exposed to the launch vehicle on Launch Complex 17A (LC-17A). The test specimens were placed at four locations illustrated in Figure 1.

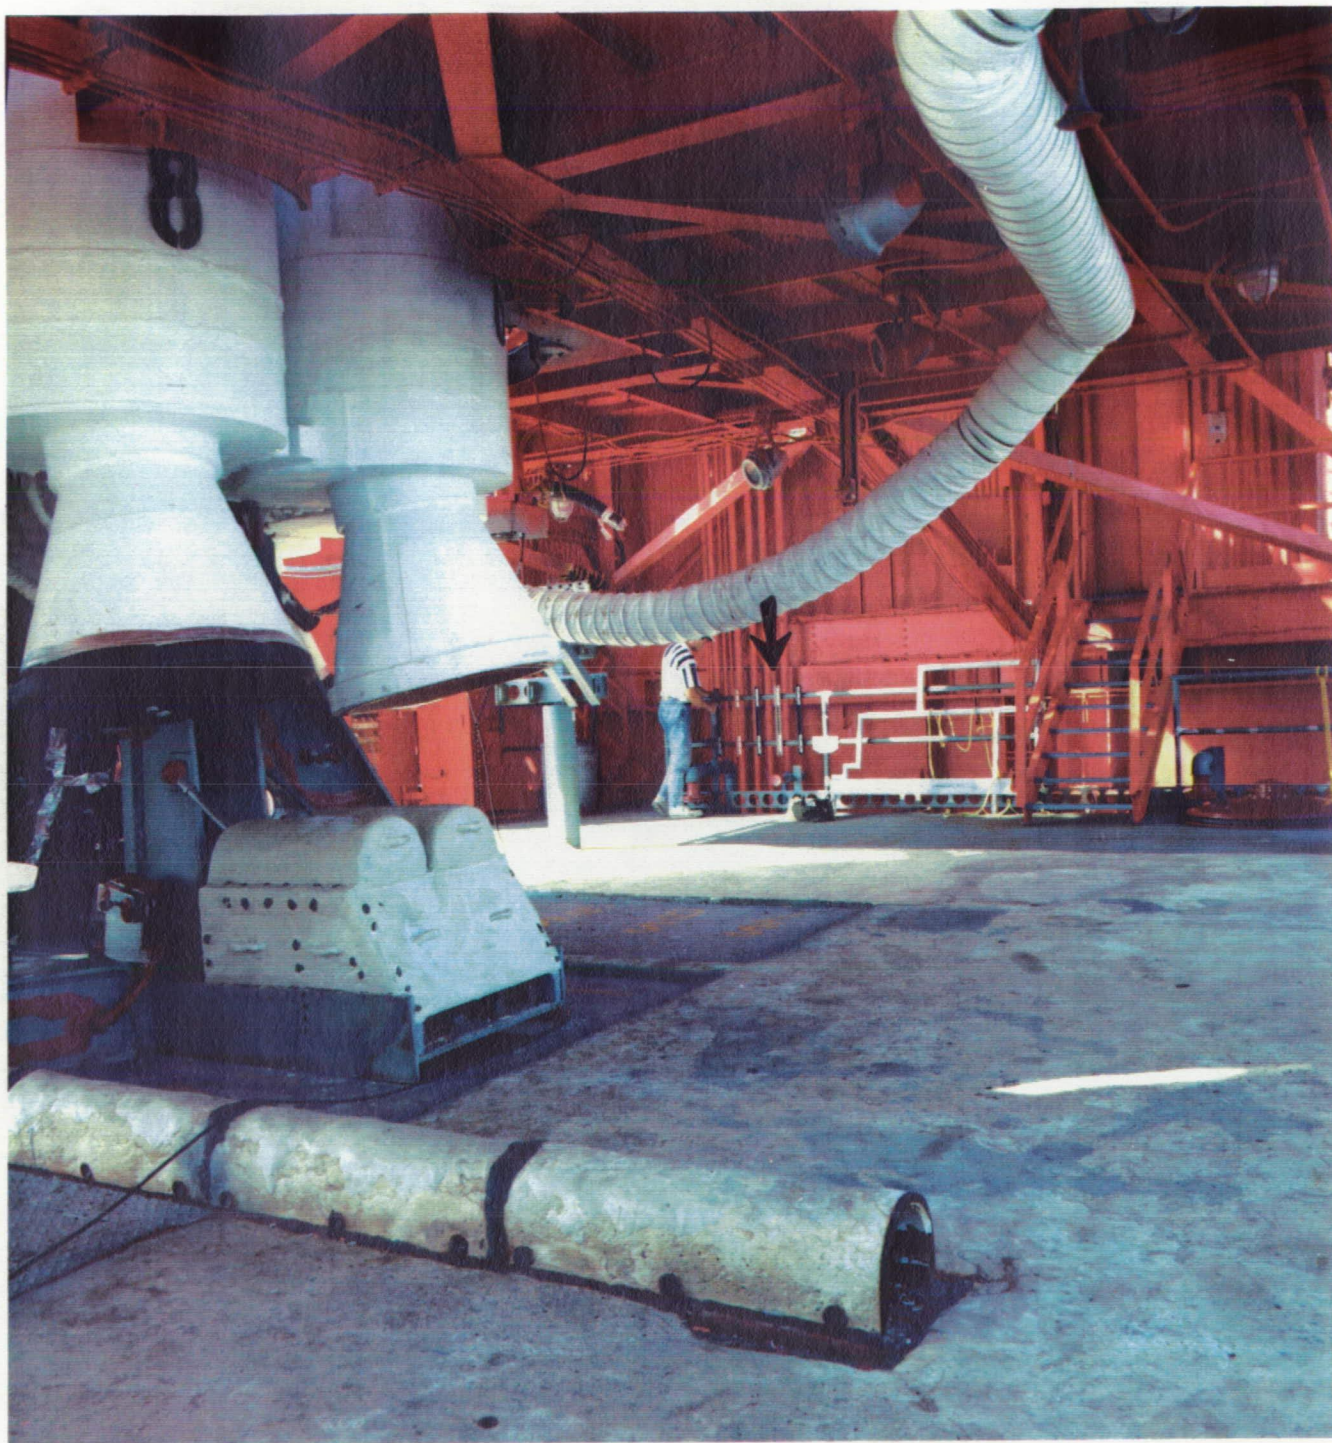
FIGURE 2

TEST LOCATION NO. 1 WAS ON THE HAND RAILS (ARROW) DIRECTLY SOUTH OF THE DELTA LAUNCH VEHICLE.

- 7.1.1 The first location, No. 1, was on the hand rail approximately 25 ft south of the vehicle centerline at the pad deck level (see Figure 2).
 - 7.1.2 The second location, No. 2, was on the handrail approximately 40 ft southwest of the vehicle and 7 to 9 ft below the pad deck level (see Figure 3).

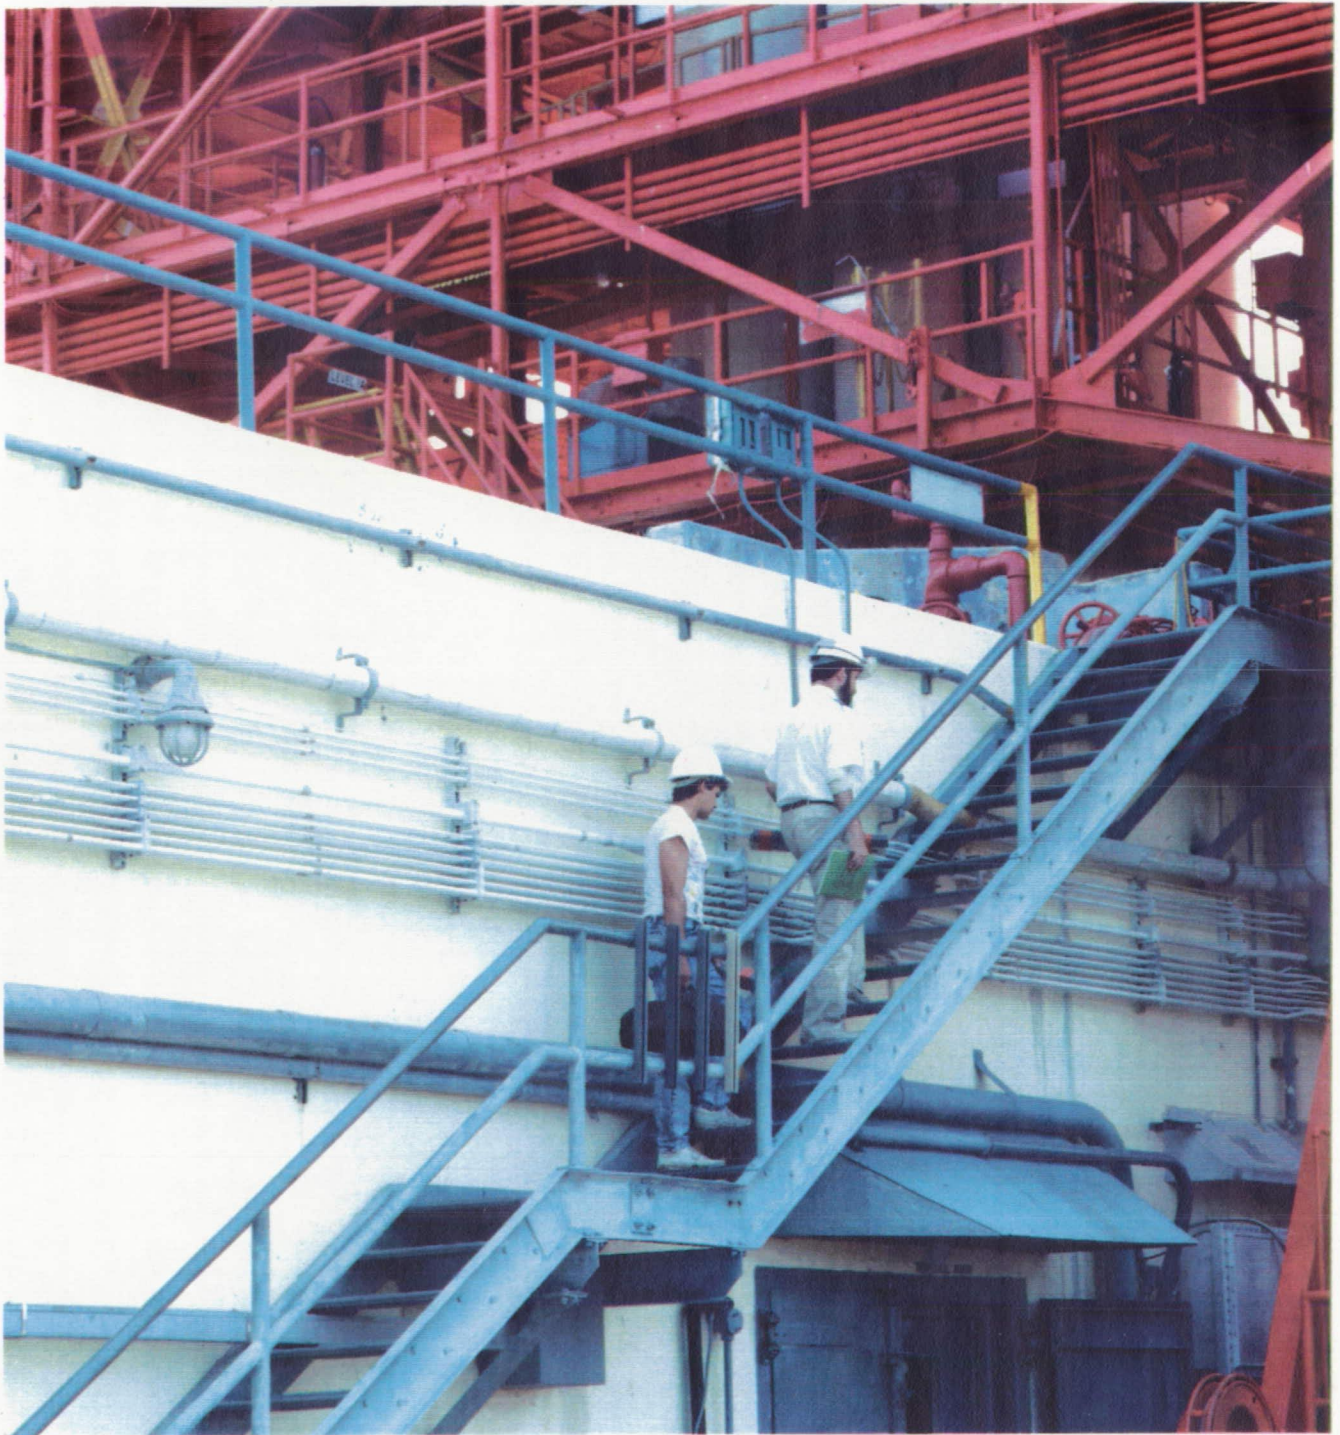
FIGURE 3

TEST LOCATION NO. 2 WAS ON THE SOUTH STAIRWAY HANDRAIL
SOUTHWEST OF THE DELTA LAUNCH VEHICLE. THE TEST SPECIMENS
WERE SHIELDED FROM THE DIRECT LAUNCH BLAST BUT ENGULFED IN
THE EXHAUST GAS CLOUD.

- 7.6.2 At location No. 2, where the test specimens were protected from the direct blast exposure but were in the cloud of hot exhaust, both the Type P and V materials appeared undamaged. The Type E, PVC, channel was found to be significantly deformed by the exposure to the hot exhaust cloud (see Figure 7). This indicates that the exposure time was sufficient for the channel to reach the PVC softening temperature in the range of 77°C (170°F), the softening temperature for the polyester resins. At this location the Type P resin probably experienced a significant loss of strength and the Type V material may have also experienced some loss of strength.

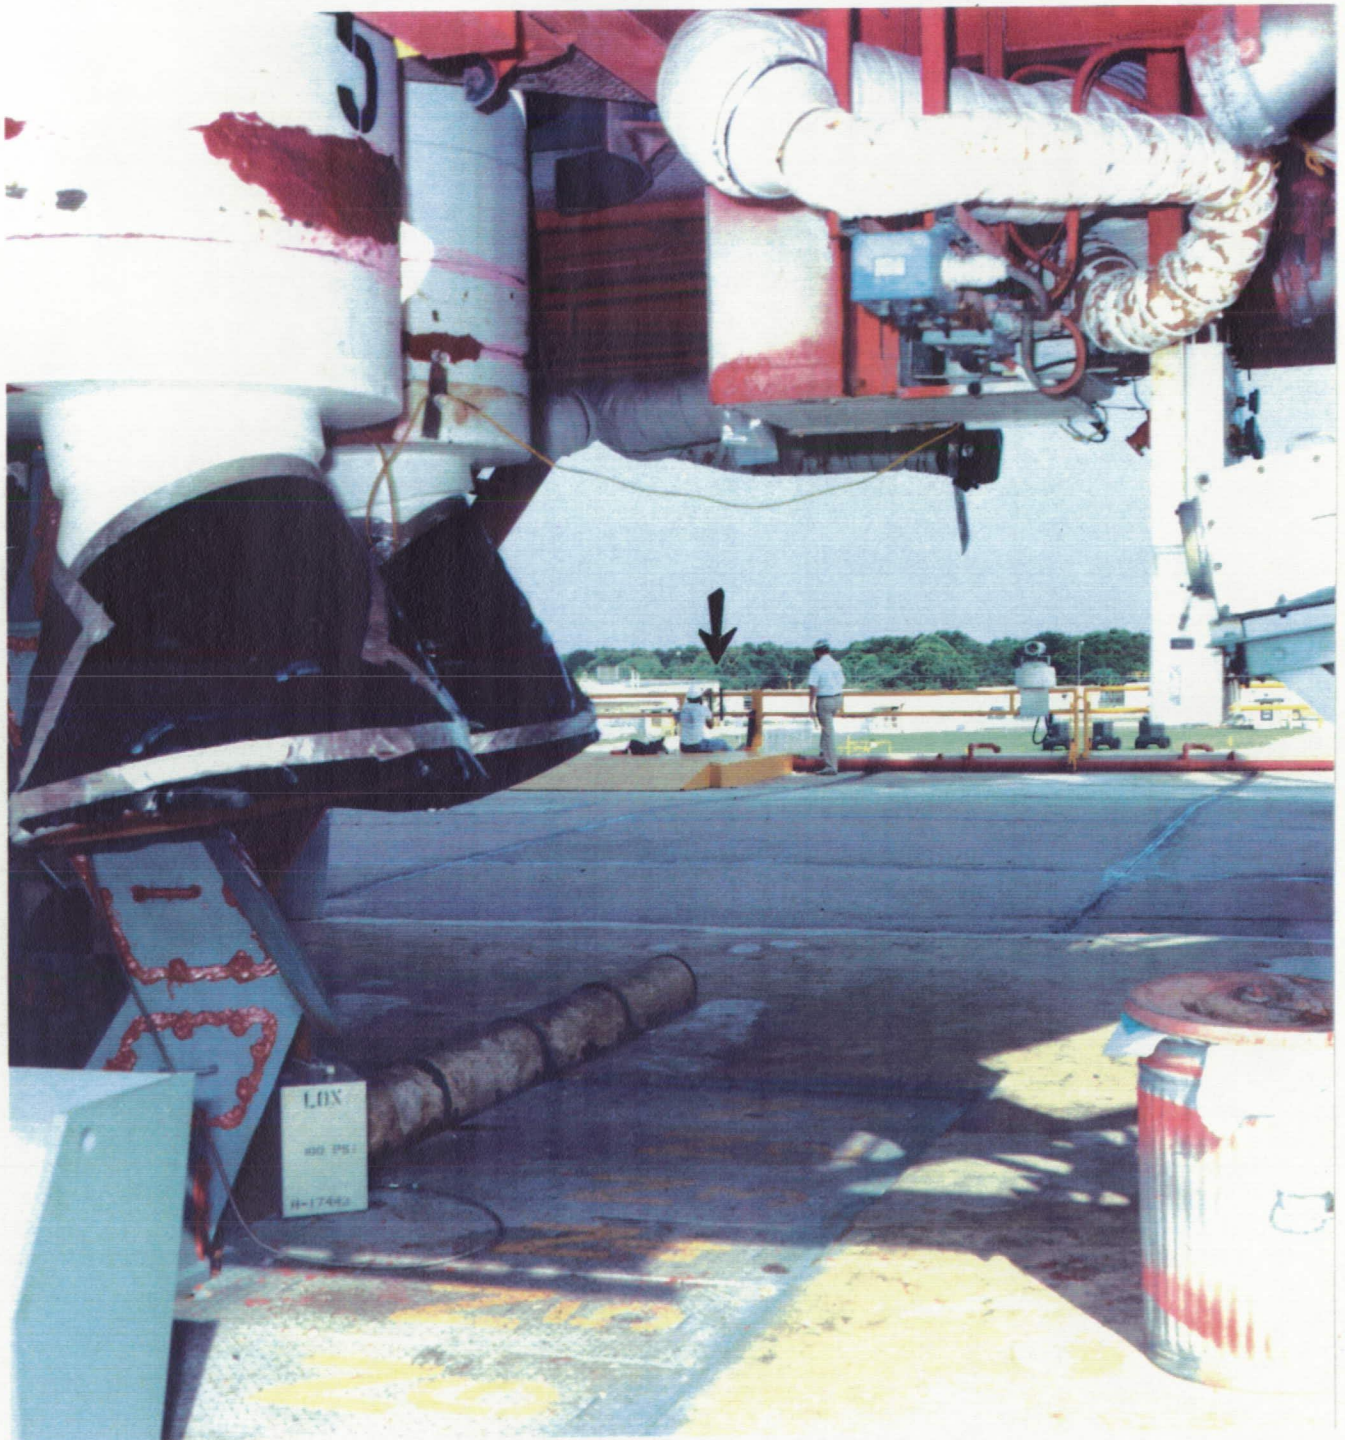
FIGURE 4

TEST LOCATION NO. 3, WAS ON THE WEST PAD DECK HANDRAILS
APPROXIMATELY 150 FT. WEST OF THE DELTA LAUNCH VEHICLE.

- 7.1.3 The third location was on a handrail approximately 150 ft west of the vehicle at the pad deck level (see Figure 4).
 - 7.1.4 The fourth location was on a west side handrail of the Mobile Service Tower (MST) approximately 22 ft above the pad deck (see Figure 5). The MST was rolled back approximately 150 yards west of the vehicle for launch.

- 7.6.3 At location No. 3 the materials probably experienced conditions similar to those at location No. 2. In addition they also experienced some small particle impact damage in the form of surface erosion. The particle impact damage may have been caused by particulate in the rocket exhaust blast, such as Martite and aluminum oxide. The Martite is the ablative material used on LC-17 and the aluminum oxide is an effluent from the SRM's exhaust.

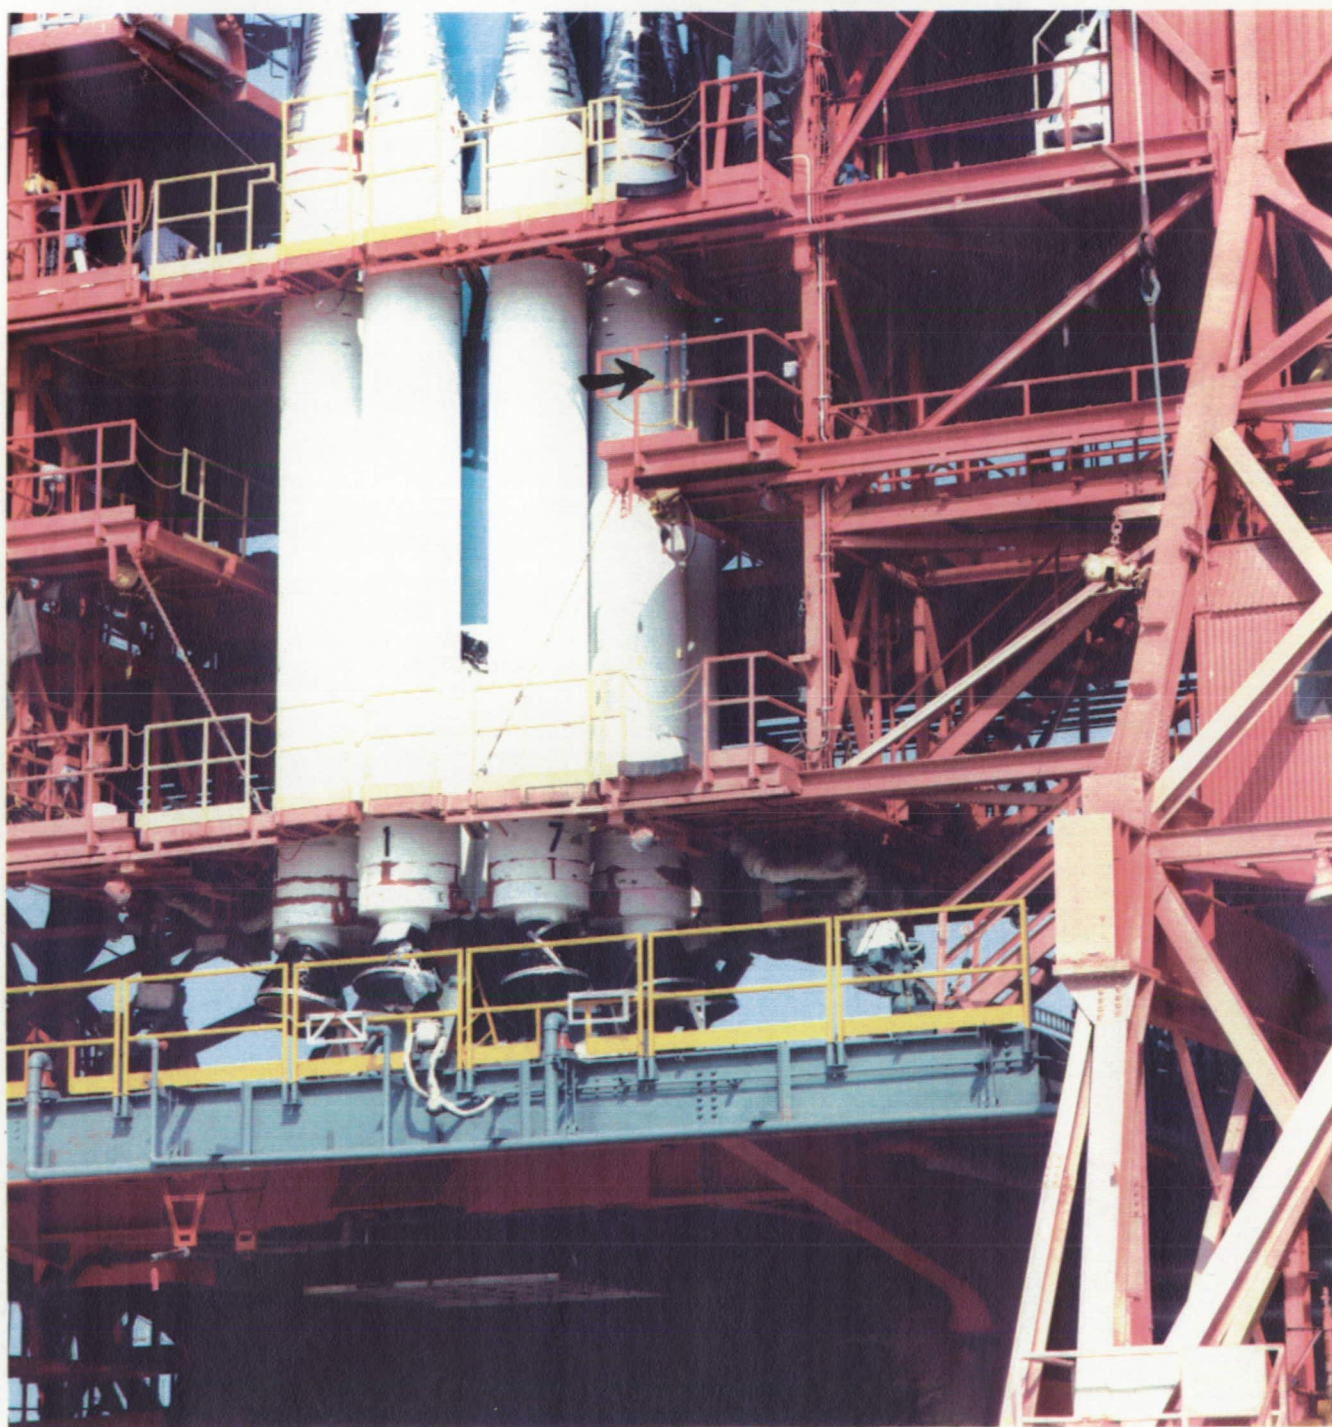
FIGURE 5

TEST LOCATION NO. 4 WAS ON THE MOBILE SERVICE TOWER WHICH WAS ROLLED BACK APPROXIMATELY 150 YARDS FROM THE DELTA VEHICLE FOR LAUNCH.

- 7.6.4 At remote location No. 4 both the PVC and polyester materials were undamaged.

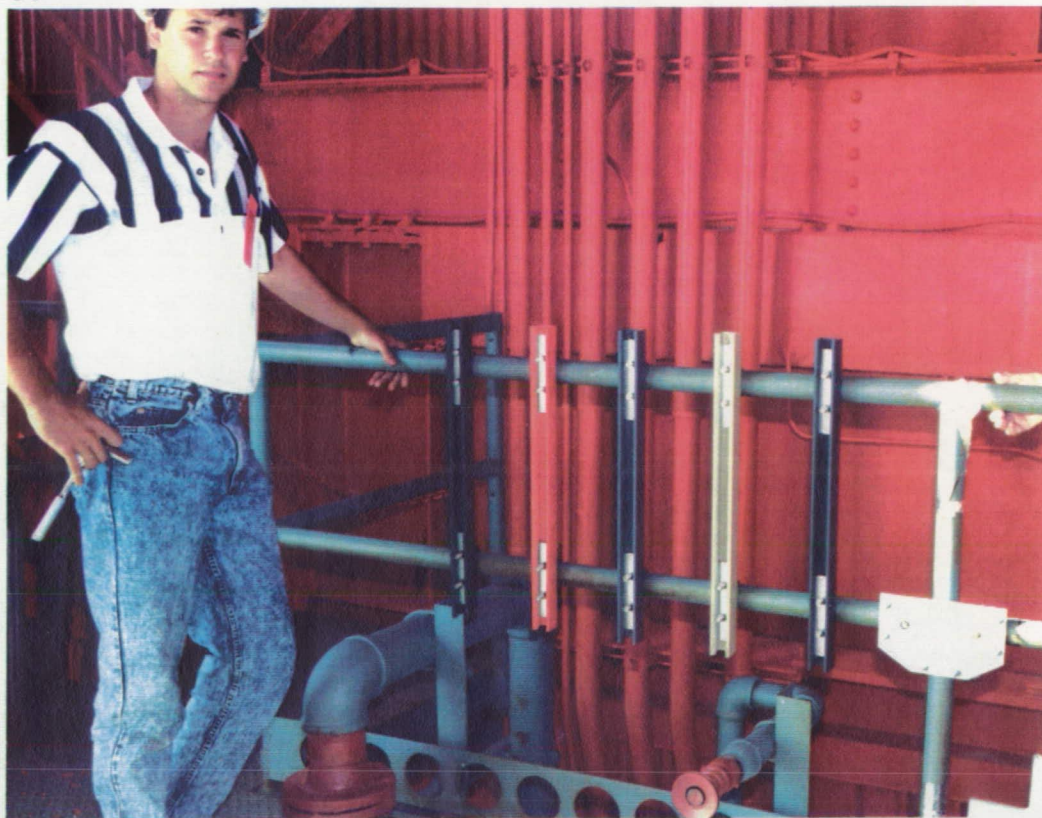
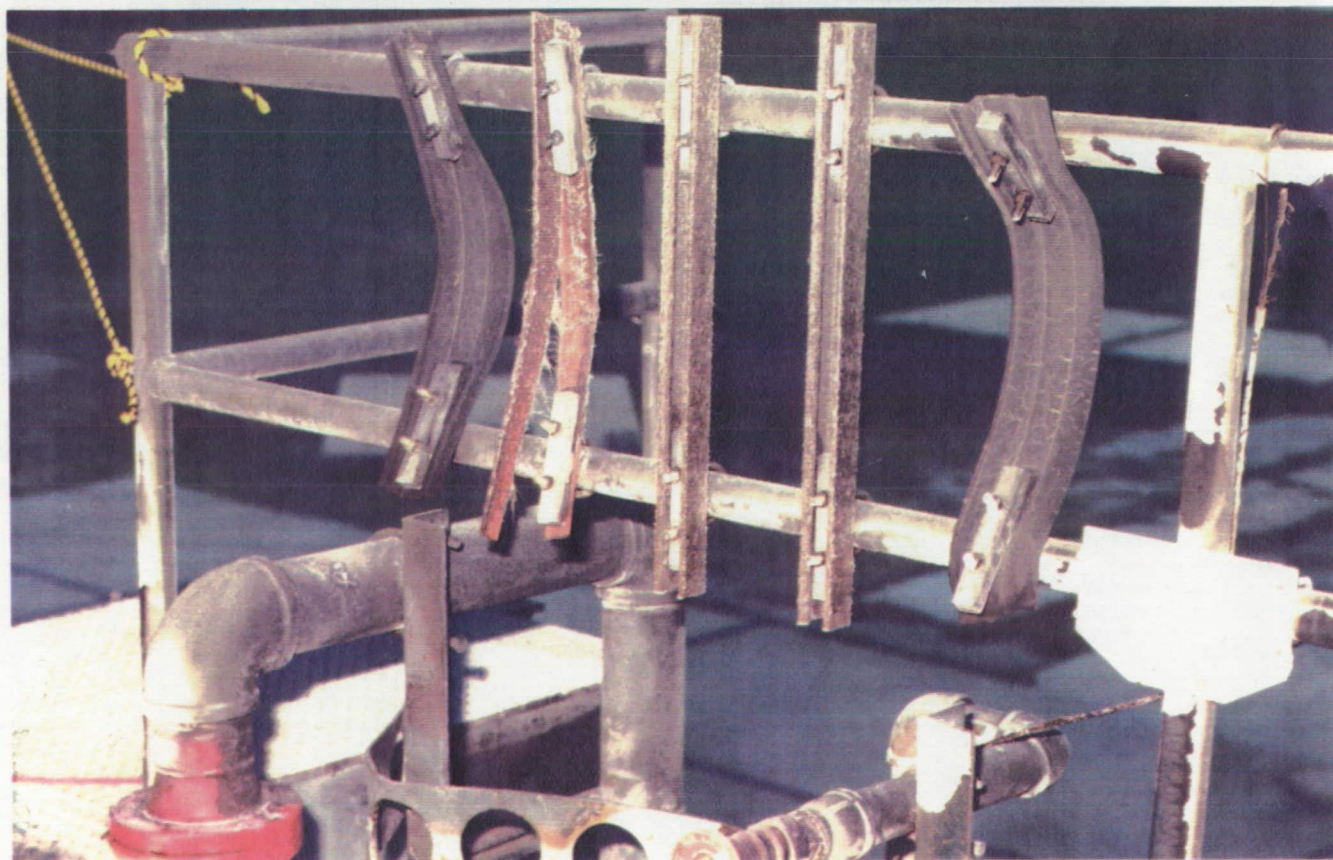
FIGURE 6

THE TEST SPECIMENS AT LOCATION NO. 1 ARE SHOWN BEFORE (TOP)
AND AFTER (BOTTOM) LAUNCH EXPOSURE.

- 7.2 At location No. 1, five channels were mounted.
 - 7.2.1 The two end channels were Aickinstrut series 20E-1500 PVC material.
 - 7.2.2 The second channel from the left was Ackinstrut 20UFR-1500 fire retardant polyester.

- 7.2.3 The center channel was a series 20P-2000 polyester material.
 - 7.2.4 The second channel from the right was a series 20V-2000 vinylester material.

- 7.6.1 At location No. 1, (see Figure 6) the material loss in the silicone rubber ablative panel indicates the launch environment was slightly less severe than at the edge of the STS mobile launch platform (MLP) during a shuttle launch at Launch Complex 39 (LC-39). The two end channels of Type E, PVC, material were charred and severely deformed by the heat and blast pressure from the SRM's. The light weight channel, 20UFR-1500, was literally destroyed by the blast pressure. The 20P-2000, polyester, and the 20V-2000, vinylester, channels maintained their structural shape; however, the polymeric material was eroded and burned away down into the fiberglass veil.

8.2.3.2 In the case of the composite channels at Location No. 1, the resin was eroded and burned down into the fiberglass veil. With the Nexus[®]-veiled composites, the exhaust blast would probably burn through the veil down to the load carrying fiber bundle, because the Nexus[®] veil is a polymer just like the matrix resin.

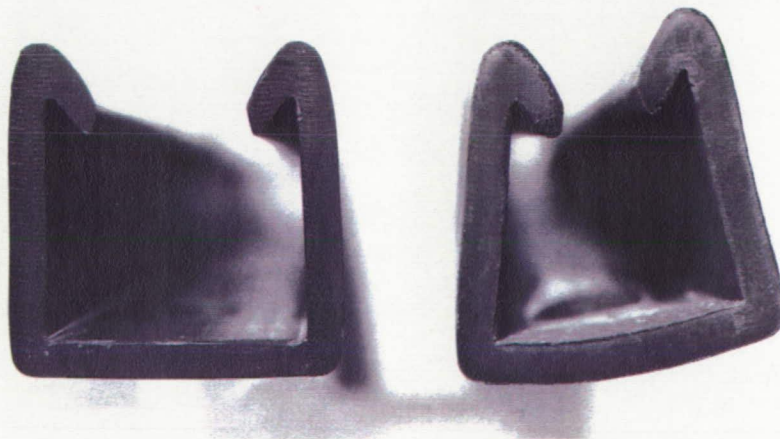
FIGURE 7

THE END OF THE TYPE E, PVC, CHANNEL AT LOCATION NO. 2 IS SHOWN (RIGHT) AFTER EXPOSURE WITH AN UNEXPOSED SEGMENT (LEFT). THE EXPOSED PVC CHANNEL HAS UNDERGONE THERMAL DEFORMATION.
